**Flood Control Project Maintenance  
Levee Inspections****LMA District Cover Sheet****Spring 2015 Levee Inspection Results****Reclamation District No. 0003 Grand Island**

**Spring 2015 Levee Inspection Results**

**Reclamation District No. 0003 Grand Island**

**Levee Inspection Report By Mile - Spring 2015**

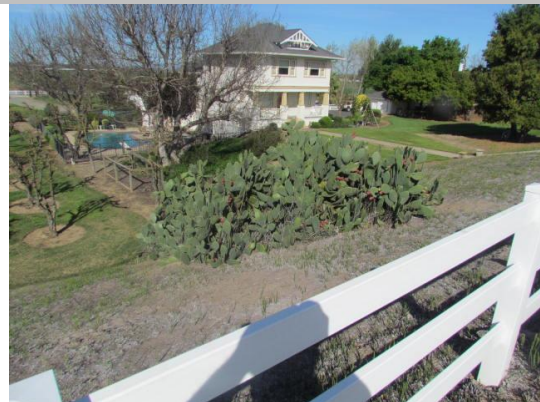
Photo 1 of 1 : SP\_2015\_RD0003\_25\_158\_20150318\_00092.jpg

LM Start	8.87	Rating **	U	Issue No.	158
LM End	8.87	Issue Type +	En	Location *	LS
Category	Earthen Levee			GPS Latitude/Longitude	
				Start	End
Item	Vegetation			38.234759 °	38.234759 °
				-121.559534 °	-121.559534 °
DWR ID	DWR_RD0003_02_s_2015_158				
Action/Comments					
Landscaping					
Inspector Comments: Large cluster of cactus on landward slope.

Looking west at cactus on landward slope and toe.

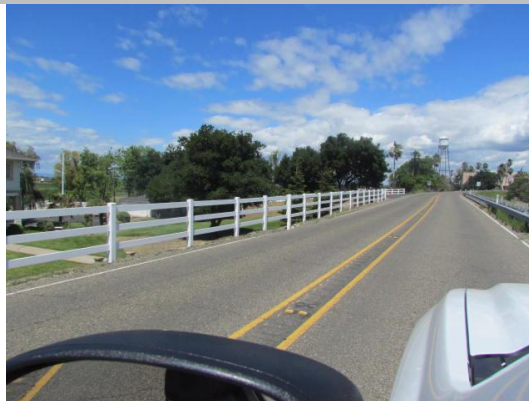
Photo 1 of 1 : SP\_2015\_RD0003\_25\_78\_20150309\_00058.jpg

LM Start	8.87	Rating **	M	Issue No.	78
LM End	8.92	Issue Type +	En	Location *	LS
Category	Earthen Levee			GPS Latitude/Longitude	
				Start	End
Item	Encroachments			38.234790 °	38.235562 °
				-121.559488 °	-121.559575 °
DWR ID	DWR_RD0003_02_s _ 2013_78				
Action/Comments					
Fence					
Inspector Comments: Unauthorized fence.

Looking northwest at unauthorized fence on landward shoulder.

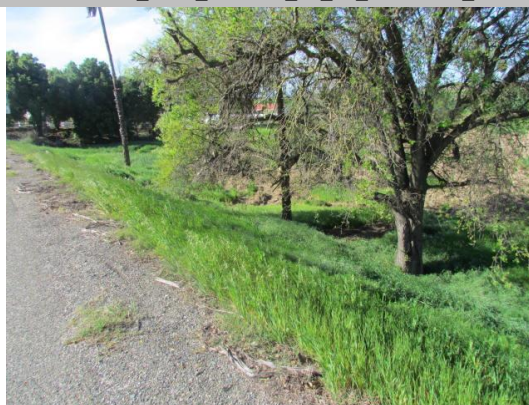
Photo 1 of 1 : SP\_2015\_RD0003\_25\_23\_20150318\_00093.jpg

LM Start	8.97	Rating **	M	Issue No.	23
LM End	8.97	Issue Type +	Ma	Location *	LS
Category	Earthen Levee			GPS Latitude/Longitude	
				Start	End
Item	Trim / Thin Trees			38.236294 °	38.236294 °
				-121.559527 °	-121.559527 °
DWR ID	DWR_RD0003_02_s _ 2012_23				
Action/Comments					
Trim trees to at least five feet above ground level.

Looking southwest at untrimmed trees on landward toe.

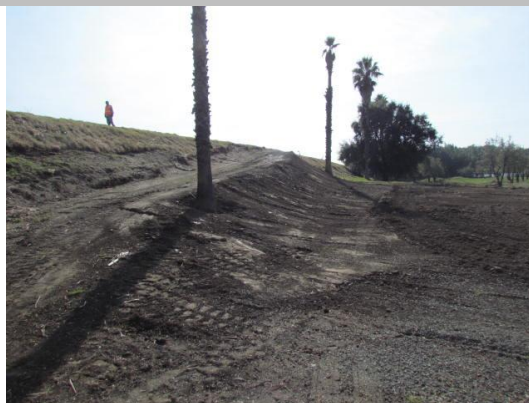
Photo 1 of 3 : SP\_2015\_RD0003\_25\_2\_20150309\_00003.jpg

LM Start	9.01	Rating **	M	Issue No.	2
LM End	9.01	Issue Type +	En	Location *	LS
Category	Earthen Levee			GPS Latitude/Longitude	
				Start	End
Item	Encroachments			38.236877 °	38.236877 °
				-121.559528 °	-121.559528 °
DWR ID	DWR_RD0003_02_s _ 2012_2				
Action/Comments					
Ramp Inspector Comments: New landowner installed unauthorized ramp on landside slope. District engineer has spoken with landowner about removing the ramp. Wild grape vines growing on ramp slope.

Looking south at unauthorized ramp on landside slope.

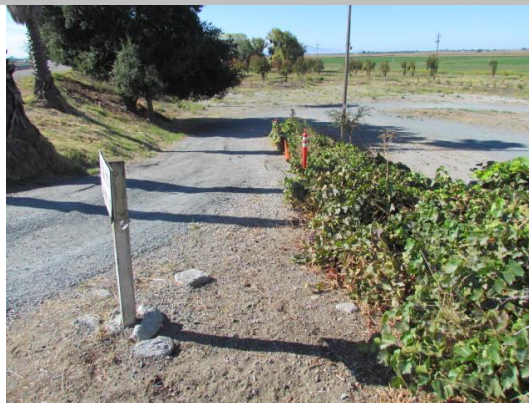
Photo 2 of 3 : SP\_2015\_RD0003\_25\_2\_20150309\_00004.jpg

LM Start	9.01	Rating **	M	Issue No.	2 (cont)	
LM End	9.01	Issue Type +	En	Location *	LS	
Category	Earthen Levee			GPS Latitude/Longitude		
				Start		End
Item	Encroachments			38.236877 °	38.236877 °	
				-121.559528 °	-121.559528 °	
DWR ID	DWR_RD0003_02_s _ 2012_2					
Action/Comments						
Ramp						
Inspector Comments: New landowner installed unauthorized ramp on landside slope. District engineer has spoken with landowner about removing the ramp. Wild grape vines growing on ramp slope.

Looking southwest at unauthorized ramp on landside. 2013

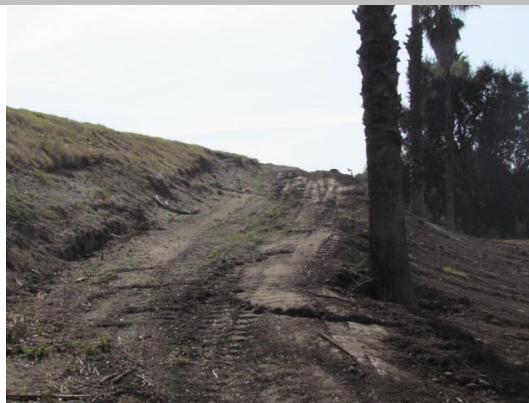
Photo 3 of 3 : SP\_2015\_RD0003\_25\_2\_20150309\_00005.jpg

Looking southeast at ramp on landside slope.

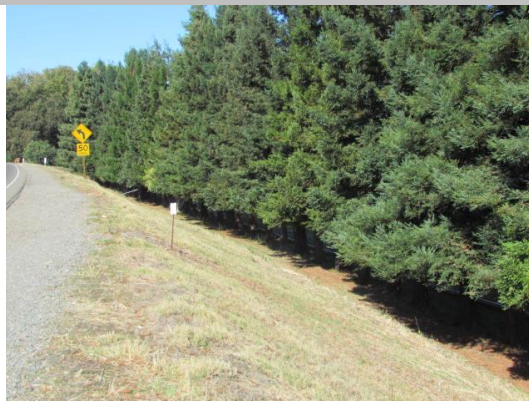
Photo 2 of 2 : SP\_2015\_RD0003\_25\_101\_20150309\_00076.jpg

LM Start	9.87	Rating **	M	Issue No.	101 (cont)		
LM End	9.99	Issue Type +	Ma	Location *	LS		
Category	Earthen Levee			GPS Latitude/Longitude			
				Start	End		
Item	Trim / Thin Trees				°		°
					°		°
DWR ID	DWR_RD0003_02_f_2013_101						
Action/Comments							
Trim and thin trees to allow visibility of the ground and room to flood fight.							
Inspector Comments: Large redwood trees at the landward toe and berm.

Looking southwest at dense redwood trees on landward toe and berm.

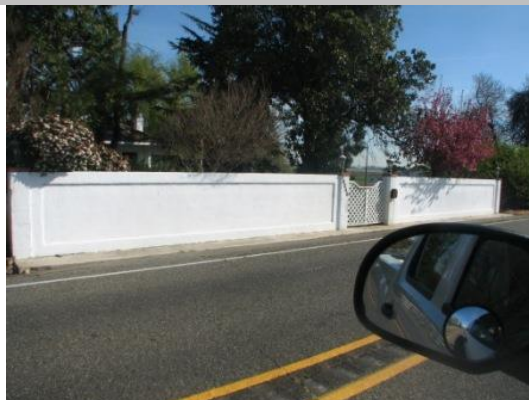
Photo 1 of 1 : SP\_2015\_RD0003\_25\_19\_20150309\_00022.jpg

LM Start	9.93	Rating **	U	Issue No.	19
LM End	9.93	Issue Type +	En	Location *	LS
Category	Earthen Levee			GPS Latitude/Longitude	
				Start	End
Item	Encroachments			38.241880 °	38.241880 °
				-121.546108 °	-121.546108 °
DWR ID	DWR_RD0003_02_s_2012_19				
Action/Comments					
Fence

Block/Concrete fence on landside shoulder at LM 10.13

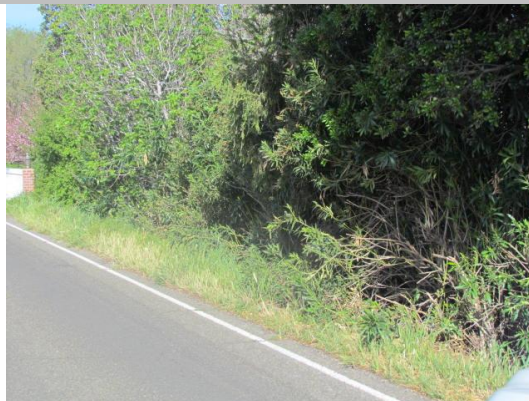
Photo 1 of 1 : SP\_2015\_RD0003\_25\_156\_20150318\_00095.jpg

LM Start	9.97	Rating **	U	Issue No.	156
LM End	9.97	Issue Type +	En	Location *	LS
Category	Earthen Levee			GPS Latitude/Longitude	
				Start	End
Item	Vegetation			38.241798 °	38.241798 °
				-121.545394 °	-121.545394 °
DWR ID	DWR_RD0003_02_s _ 2015_156				
Action/Comments					
Landscaping					
Inspector Comments: Oleander blocking view of landward slope.

Looking west at dense landscaping on landward shoulder and slope.

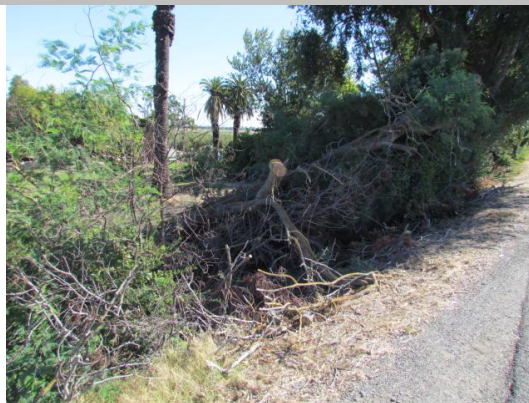
Photo 1 of 1 : SP\_2015\_RD0003\_25\_102\_20150309\_00077.jpg

LM Start	10.35	Rating **	A/W	Issue No.	102
LM End	10.35	Issue Type +	Ma	Location *	LS
Category	Earthen Levee			GPS Latitude/Longitude	
				Start	End
Item	Encroachments				°
					°
DWR ID	DWR_RD0003_02_f_2013_102				
Action/Comments					
Tree or limb					
Inspector Comments: Downed tree on landward slope.

Looking west at downed tree on landward slope.

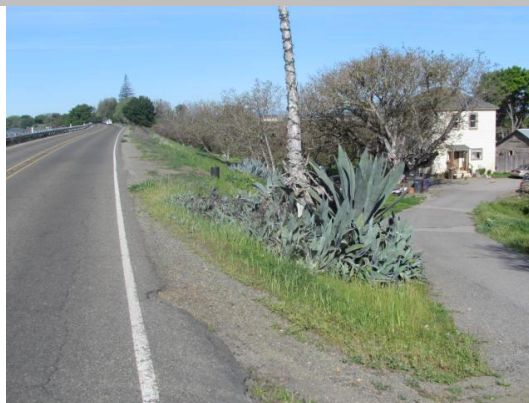
Photo 1 of 2 : SP\_2015\_RD0003\_25\_81\_20150318\_00097.jpg

LM Start	10.43	Rating **	M	Issue No.	81
LM End	10.43	Issue Type +	Ma	Location *	LS
Category	Earthen Levee			GPS Latitude/Longitude	
				Start	End
Item	Vegetation			38.239850 °	38.239850 °
				-121.537237 °	-121.537237 °
DWR ID	DWR_RD0003_02_s_2013_81				
Action/Comments					
Remove the wild growth other than native grasses from the levee slopes.					
Inspector Comments: Century plant on landward shoulder.

Looking south at century plant on landward slope. (Spring 2015)

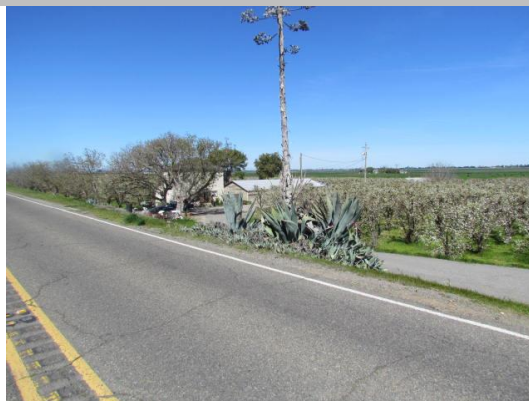
Photo 2 of 2 : SP\_2015\_RD0003\_25\_81\_20150309\_00062.jpg

Looking southwest at century plant on landward shoulder and slope.

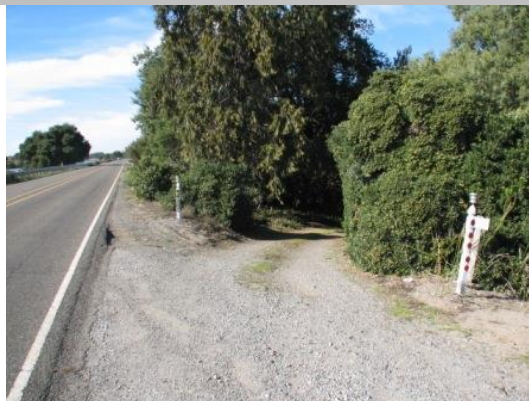
Photo 1 of 1 : SP\_2015\_RD0003\_25\_66\_20150309\_00048.jpg

LM Start	10.54	Rating **	U	Issue No.	66
LM End	10.54	Issue Type +	En	Location *	LS
Category	Earthen Levee			GPS Latitude/Longitude	
				Start	End
Item	Vegetation			38.239499 °	38.239499 °
				-121.535338 °	-121.535338 °
DWR ID	DWR_RD0003_02_s _ 2012_66				
Action/Comments					
Landscaping

Landscaping on levee slope and toe obstructs access and visibility.

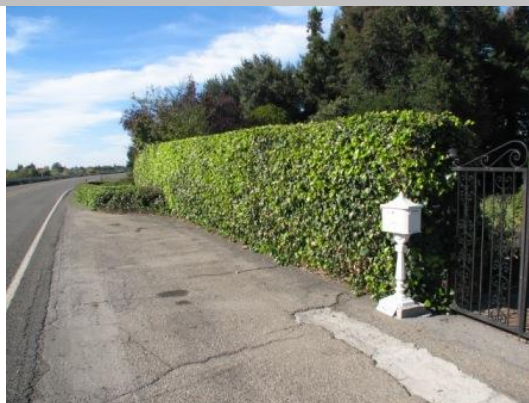
Photo 1 of 1 : SP\_2015\_RD0003\_25\_67\_20150309\_00049.jpg

LM Start	10.78	Rating **	U	Issue No.	67
LM End	10.78	Issue Type +	En	Location *	LS
Category	Earthen Levee			GPS Latitude/Longitude	
				Start	End
Item	Vegetation			38.238812 °	38.238812 °
				-121.531031 °	-121.531031 °
DWR ID	DWR_RD0003_02_s _ 2012_67				
Action/Comments					
Landscaping

Landscaping on levee slope obstructs access and visibility.

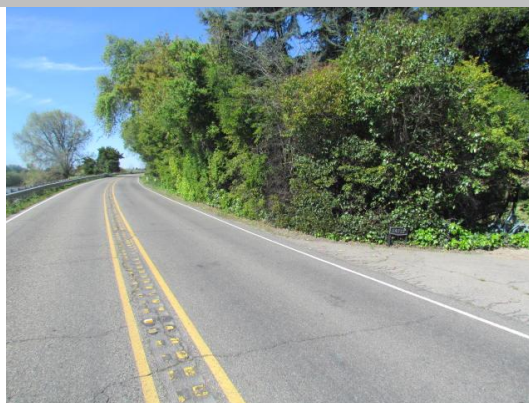
Photo 1 of 1 : SP\_2015\_RD0003\_25\_68\_20150309\_00050.jpg

LM Start	10.81	Rating **	U	Issue No.	68
LM End	10.90	Issue Type +	En	Location *	LS
Category	Earthen Levee			GPS Latitude/Longitude	
				Start	End
Item	Vegetation			38.238817 °	38.238959 °
				-121.530372 °	-121.528758 °
DWR ID	DWR_RD0003_02_s _ 2012_68				
Action/Comments					
Landscaping

Looking south at dense landscaping on landward shoulder and slope.

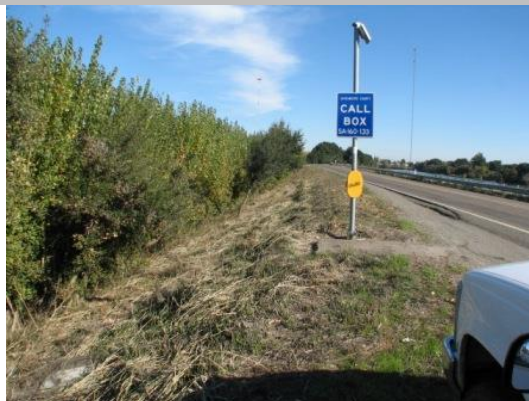
Photo 1 of 1 : SP\_2015\_RD0003\_25\_69\_20150309\_00051.jpg

LM Start	10.91	Rating **	M	Issue No.	69
LM End	11.14	Issue Type +	En	Location *	LS
Category	Earthen Levee			GPS Latitude/Longitude	
				Start	End
Item	Vegetation			38.238998 °	38.239825 °
				-121.528585 °	-121.524558 °
DWR ID	DWR_RD0003_02_s_2012_69				
Action/Comments					
Landscaping

Landscaping trees on levee slope an toe obstruct access and visibility.

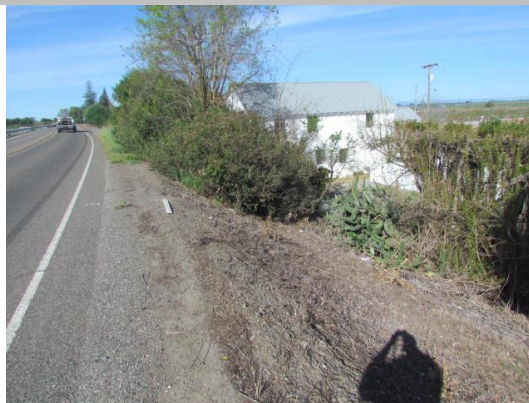
Photo 1 of 2 : SP\_2015\_RD0003\_25\_84\_20150318\_00098.jpg

LM Start	11.10	Rating **	U	Issue No.	84
LM End	11.10	Issue Type +	En	Location *	LS
Category	Earthen Levee			GPS Latitude/Longitude	
				Start	End
Item	Vegetation			38.239730 °	38.239730 °
				-121.525190 °	-121.525190 °
DWR ID	DWR_RD0003_02_s _ 2013_84				
Action/Comments					
Landscaping					
Inspector Comments: Oleander on landward shoulder.

Looking south at dense landscaping on landward slope and toe. (Spring 2015)

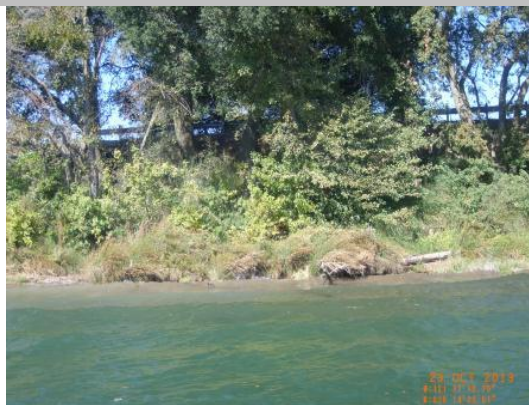
Photo 1 of 2 : SP\_2015\_RD0003\_25\_20\_20150309\_00023.jpg

LM Start	11.33	Rating **	M	Issue No.	20
LM End	11.42	Issue Type +	Ma	Location *	WS
Category	Supplemental			GPS Latitude/Longitude	
				Start	End
Item	USACE Erosion Survey			38.239870 °	38.239983 °
				-121.520989 °	-121.519361 °
DWR ID	DWR_RD0003_02_f __ 2014_20				
Action/Comments					
Inspector Comments: 2009 - Hole left in levee toe from a fallen tree. Could be repaired under maintenance. 2010 - Minor new erosion. 2013: No observed changes. [2013 Site ID: SAC_26-3_R]

USACE 2013 Photo #1

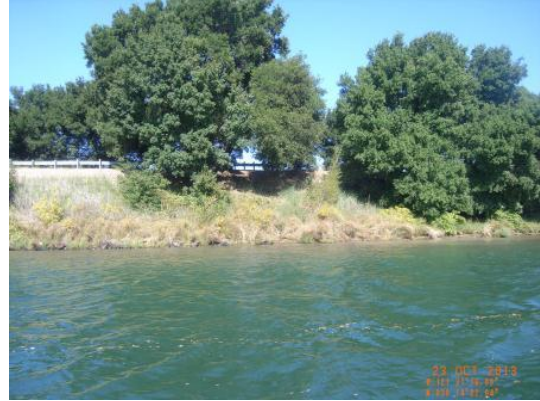
Photo 2 of 2 : SP\_2015\_RD0003\_25\_20\_20150309\_00024.jpg

LM Start	11.33	Rating **	M	Issue No.	20 (cont)
LM End	11.42	Issue Type +	Ma	Location *	WS
Category	Supplemental			GPS Latitude/Longitude	
				Start	End
Item	USACE Erosion Survey			38.239870 °	38.239983 °
				-121.520989 °	-121.519361 °
DWR ID	DWR_RD0003_02_f_2014_20				
Action/Comments					
Inspector Comments: 2009 - Hole left in levee toe from a fallen tree. Could be repaired under maintenance. 2010 - Minor new erosion. 2013: No observed changes. [2013 Site ID: SAC_26-3_R]

USACE 2013 Photo #2

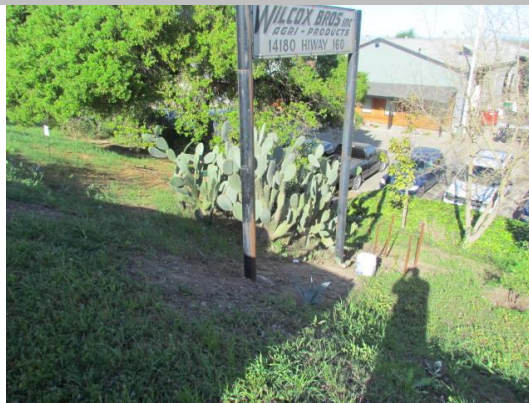
Photo 1 of 1 : SP\_2015\_RD0003\_25\_155\_20150318\_00099.jpg

LM Start	11.58	Rating **	M	Issue No.	155
LM End	11.58	Issue Type +	En	Location *	LS
Category	Earthen Levee			GPS Latitude/Longitude	
				Start	End
Item	Vegetation			38.241412 °	38.241412 °
				-121.517027 °	-121.517027 °
DWR ID	DWR_RD0003_02_s _ 2015_155				
Action/Comments					
Landscaping					
Inspector Comments: Cactus on landward slope.

Looking southwest at cactus on landward slope and toe.

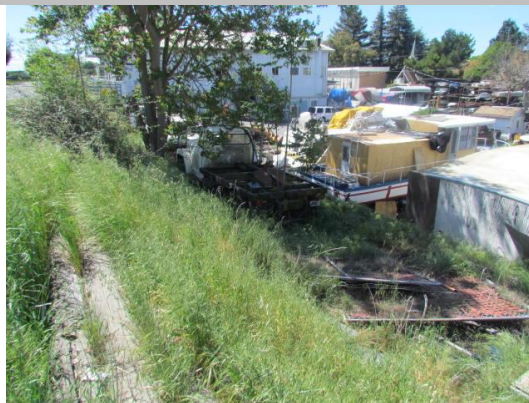
Photo 1 of 2 : SP\_2015\_RD0003\_25\_86\_20150309\_00066.jpg

LM Start	11.90	Rating **	M	Issue No.	86
LM End	11.90	Issue Type +	En	Location *	LS
Category	Earthen Levee			GPS Latitude/Longitude	
				Start	End
Item	Encroachments			38.244942 °	38.244942 °
				-121.513132 °	-121.513132 °
DWR ID	DWR_RD0003_02_s _ 2013_86				
Action/Comments					
Abandoned vehicles					
Inspector Comments: Abandoned vehicles and material on landward toe.

Looking southwest at abandoned vehicles and material on landward slope and toe.

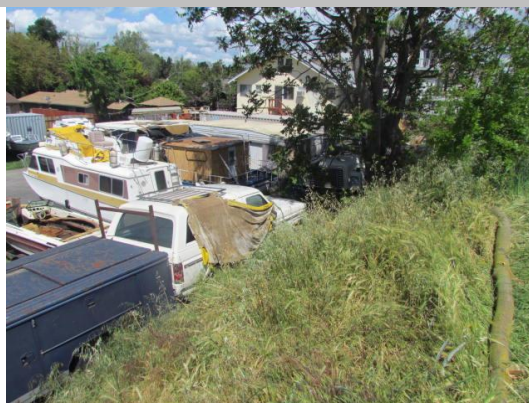
Photo 2 of 2 : SP\_2015\_RD0003\_25\_86\_20150309\_00067.jpg

Looking northwest at abandoned vehicles on landward toe.

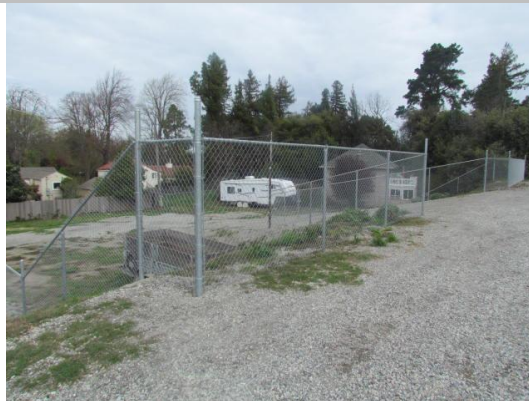
Photo 1 of 1 : SP\_2015\_RD0003\_25\_267\_20150309\_00081.jpg

LM Start	11.99	Rating **	M	Issue No.	267
LM End	11.99	Issue Type +	En	Location *	LS
Category	Earthen Levee			GPS Latitude/Longitude	
				Start	End
Item	Encroachments			38.246025 °	38.246025 °
				-121.512327 °	-121.512327 °
DWR ID	DWR_RD0003_02_s_2012_267				
Action/Comments					
Fence					
Inspector Comments: Landowner installed a new fence on the landside of levee.

Looking northwest at new fence on landside shoulder and slope.

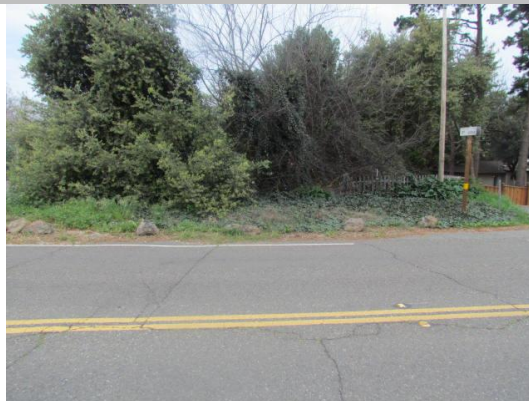
Photo 1 of 1 : SP\_2015\_RD0003\_25\_31\_20150309\_00031.jpg

LM Start	12.01	Rating **	M	Issue No.	31
LM End	12.08	Issue Type +	En	Location *	LS
Category	Earthen Levee			GPS Latitude/Longitude	
				Start	End
Item	Vegetation			38.246310 °	38.247332 °
				-121.512157 °	-121.511773 °
DWR ID	DWR_RD0003_02_s_2012_31				
Action/Comments					
Landscaping					
Inspector Comments: Landscaping and new wooden fence on landside slope.

Looking west at dense landscaping on landside shoulder and slope.

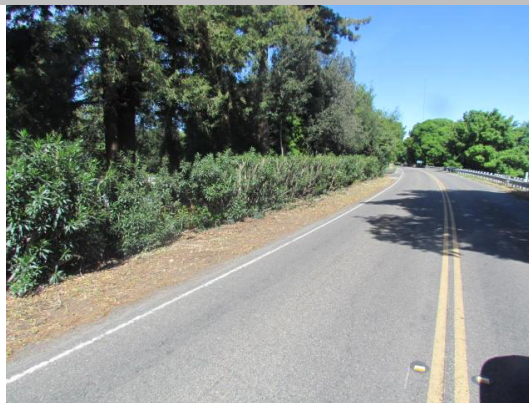
Photo 1 of 2 : SP\_2015\_RD0003\_25\_32\_20150318\_00100.jpg

LM Start	12.11	Rating **	M	Issue No.	32
LM End	12.18	Issue Type +	En	Location *	LS
Category	Earthen Levee			GPS Latitude/Longitude	
				Start	End
Item	Vegetation			38.247788 °	38.248682 °
				-121.511695 °	-121.511657 °
DWR ID	DWR_RD0003_02_s _ 2012_32				
Action/Comments					
Landscaping Inspector Comments: Oleander partially blocking view of levee on landside slope.

Looking northwest at trimmed oleander partially blocking view of landward slope. (Spring 2015)

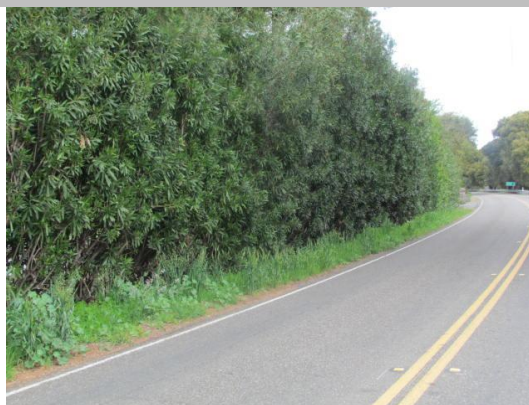
Photo 2 of 2 : SP\_2015\_RD0003\_25\_32\_20150309\_00032.jpg

Looking northwest at oleander on landside shoulder. (Spring 2014)

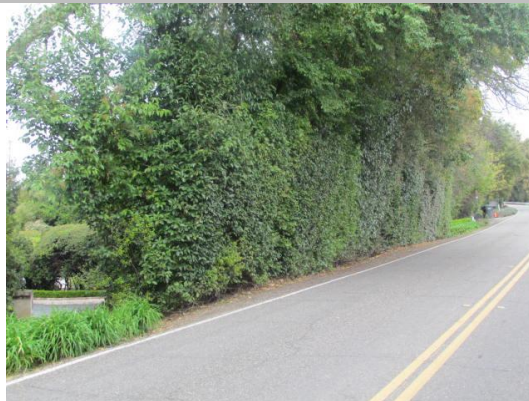
Photo 1 of 1 : SP\_2015\_RD0003\_25\_34\_20150309\_00033.jpg

LM Start	12.29	Rating **	U	Issue No.	34
LM End	12.33	Issue Type +	En	Location *	LS
Category	Earthen Levee			GPS Latitude/Longitude	
				Start	End
Item	Vegetation			38.250348 °	38.250808 °
				-121.511959 °	-121.512152 °
DWR ID	DWR_RD0003_02_s_2012_34				
Action/Comments					
Landscaping

Looking northwest at dense landscaping on landside shoulder.

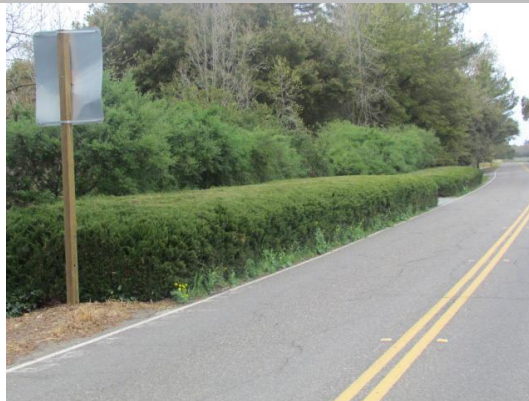
Photo 1 of 1 : SP\_2015\_RD0003\_25\_37\_20150309\_00035.jpg

LM Start	12.54	Rating **	U	Issue No.	37
LM End	12.63	Issue Type +	En	Location *	LS
Category	Earthen Levee			GPS Latitude/Longitude	
				Start	End
Item	Vegetation			38.253593 °	38.254590 °
				-121.513883 °	-121.514862 °
DWR ID	DWR_RD0003_02_s _ 2012_37				
Action/Comments					
Landscaping					
Inspector Comments: Dense landscaping on landside shoulder and slope.

Looking northwest at dense landscaping on landside shoulder and slope.

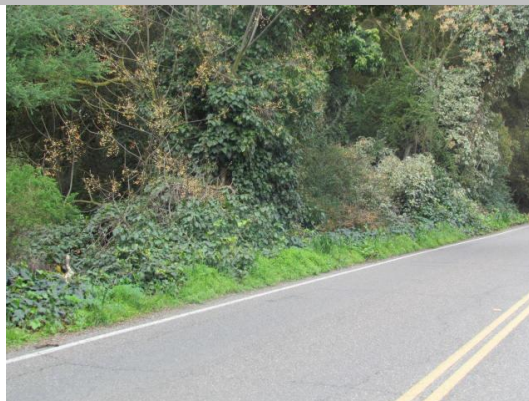
Photo 1 of 1 : SP\_2015\_RD0003\_25\_82\_20150309\_00063.jpg

LM Start	13.03	Rating **	U	Issue No.	82
LM End	13.06	Issue Type +	En	Location *	LS
Category	Earthen Levee			GPS Latitude/Longitude	
				Start	End
Item	Vegetation			38.258703 °	38.259003 °
				-121.520160 °	-121.520557 °
DWR ID	DWR_RD0003_02_s_2012_82				
Action/Comments					
Landscaping					
Inspector Comments: Dense landscaping blocking view of landside slope.

Looking west at dense landscaping on landside shoulder and slope.

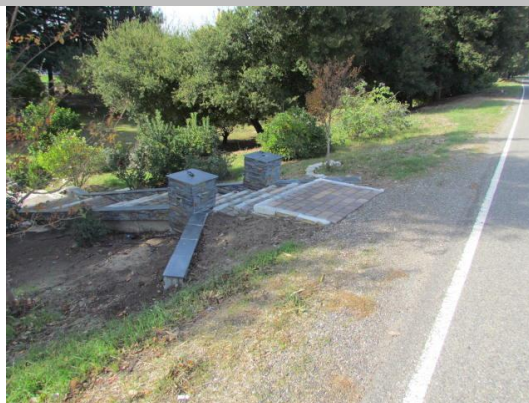
Photo 1 of 2 : SP\_2015\_RD0003\_25\_9\_20150309\_00009.jpg

LM Start	13.36	Rating **	M	Issue No.	9
LM End	13.36	Issue Type +	Ma	Location *	LS
Category	Earthen Levee			GPS Latitude/Longitude	
				Start	End
Item	Encroachments			38.262125 °	38.262125 °
				-121.524405 °	-121.524405 °
DWR ID	DWR_RD0003_02_s_2012_9				
Action/Comments					
Stairway Inspector Comments: Landowner installed unauthorized stairs on landside slope.

Looking northwest at stairs on landside slope.

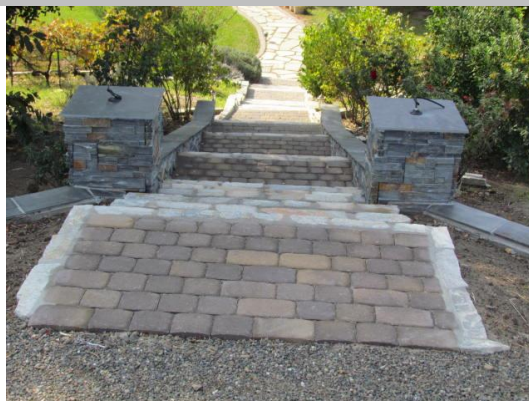
Photo 2 of 2 : SP\_2015\_RD0003\_25\_9\_20150309\_00010.jpg

Looking west at stairs on landside slope.

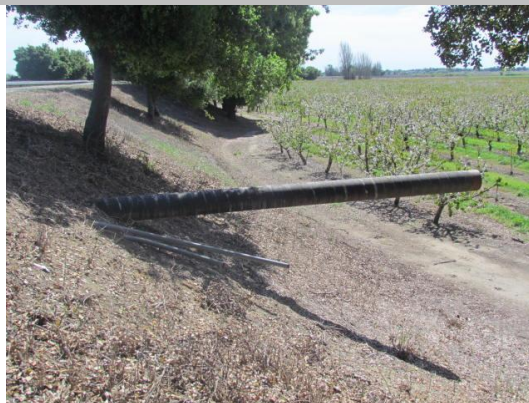
Photo 1 of 3 : SP\_2015\_RD0003\_25\_161\_20150318\_00102.jpg

LM Start	13.70	Rating **	U	Issue No.	161
LM End	13.70	Issue Type +	En	Location *	LS
Category	Interior Drainage & Piping Systems			GPS Latitude/Longitude	
				Start	End
Item	Metal Pipes			38.265470 °	38.265470 °
				-121.528788 °	-121.528788 °
DWR ID	DWR_RD0003_02_s _ 2015_161				
Action/Comments					
Inspector Comments: Pipe should be properly abandoned and or removed.

Looking west at metal irrigation pipe and electrical conduits on landward slope.

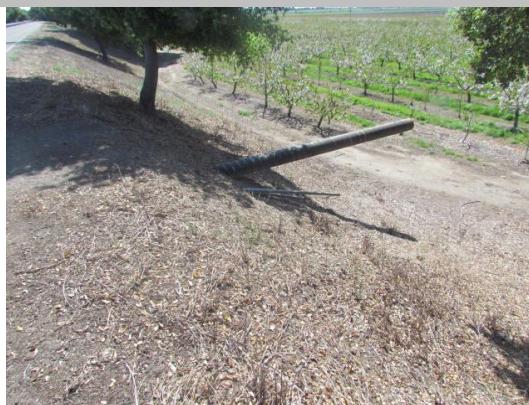
Photo 2 of 3 : SP\_2015\_RD0003\_25\_161\_20150318\_00101.jpg

Looking west at metal irrigation pipe and electrical conduits on landward slope.

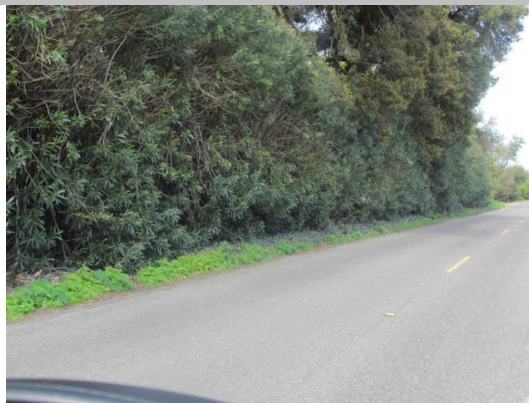
Photo 1 of 2 : SP\_2015\_RD0003\_25\_79\_20150309\_00059.jpg

LM Start	15.58	Rating **	U	Issue No.	79
LM End	15.68	Issue Type +	En	Location *	LS
Category	Earthen Levee			GPS Latitude/Longitude	
				Start	End
Item	Vegetation			38.284124 °	38.285129 °
				-121.554084 °	-121.555342 °
DWR ID	DWR_RD0003_02_s _ 2012_79				
Action/Comments					
Landscaping

Looking northwest at dense landscaping on landside shoulder and slope.

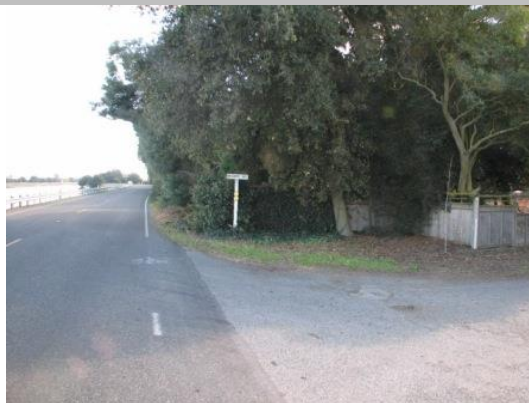
Photo 2 of 2 : SP\_2015\_RD0003\_25\_79\_20150309\_00060.jpg

Looking south at landscaping on levee slope and toe obstruct access and visibility.

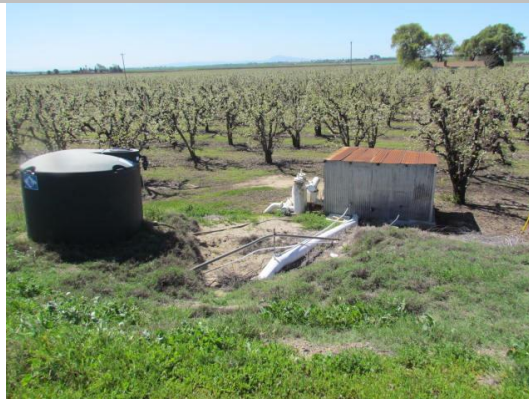
Photo 1 of 2 : SP\_2015\_RD0003\_25\_75\_20150309\_00054.jpg

LM Start	16.04	Rating **	M	Issue No.	75
LM End	16.04	Issue Type +	En	Location *	LS
Category	Earthen Levee			GPS Latitude/Longitude	
				Start	End
Item	Encroachments			38.289126 °	38.289126 °
				-121.559631 °	-121.559631 °
DWR ID	DWR_RD0003_02_s_2014_75				
Action/Comments					
Tank Inspector Comments: Tank is located next to irrigation system on landside slope.

Looking west at tank next to pump house on landward slope.

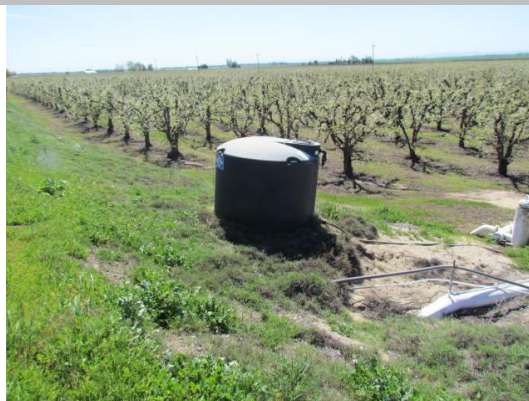
Photo 2 of 2 : SP\_2015\_RD0003\_25\_75\_20150309\_00055.jpg

Looking southwest at tank on landside slope.

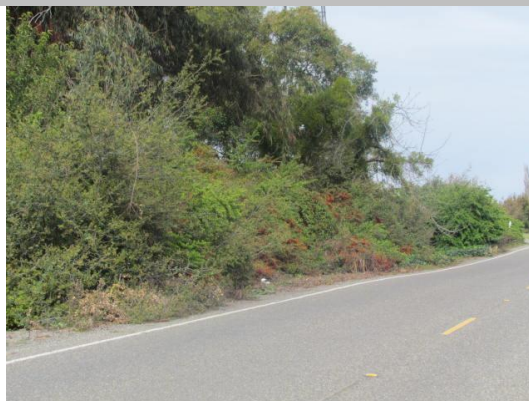
Photo 1 of 1 : SP\_2015\_RD0003\_25\_60\_20150309\_00047.jpg

LM Start	16.20	Rating **	U	Issue No.	60
LM End	16.25	Issue Type +	En	Location *	LS
Category	Earthen Levee			GPS Latitude/Longitude	
				Start	End
Item	Vegetation			38.290742 °	38.291390 °
				-121.561575 °	-121.562268 °
DWR ID	DWR_RD0003_02_s_2012_60				
Action/Comments					
Landscaping

Looking west at dense landscaping on landside shoulder and slope.

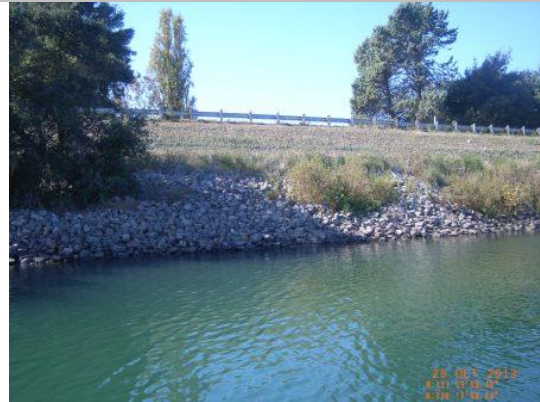
Photo 1 of 1 : SP\_2015\_RD0003\_25\_28\_20150309\_00026.jpg

LM Start	16.54	Rating **	M	Issue No.	28
LM End	16.63	Issue Type +	Ma	Location *	WS
Category	Supplemental			GPS Latitude/Longitude	
				Start	End
Item	USACE Erosion Survey			38.294757 °	38.295730 °
				-121.565376 °	-121.566295 °
DWR ID	DWR_RD0003_02_f_2014_28				
Action/Comments					
Inspector Comments: 1997 - Erosion of supper sandy levee material above the water line, straight reach. 1999 - Small pocket repaired with rock. 2005 - Downstream 400 ft have been repaired. 2011 - Site is overgrown with vegetation. 2013: No observed changes. [2013 Site ID: SAC_31-6_R]

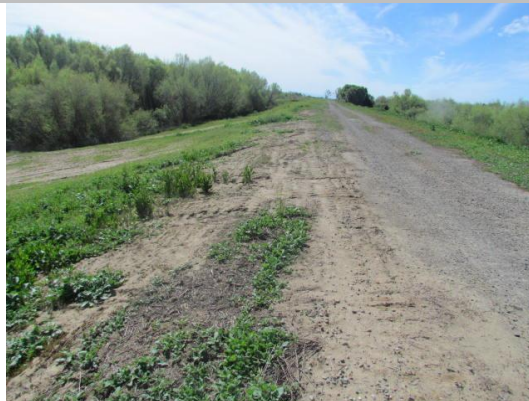
Photo 1 of 3 : SP\_2015\_RD0003\_610\_3\_20150318\_00005.jpg

LM Start	0.06	Rating **	A/W	Issue No.	3
LM End	0.06	Issue Type +	Ma	Location *	LS
Category	Earthen Levee			GPS Latitude/Longitude	
				Start	End
Item	Slope Stability			38.181427 °	38.181427 °
				-121.653622 °	-121.653622 °
DWR ID	DWR_RD0003_03_s_2013_3				
Action/Comments					
Repair slope instability. Inspector Comments: LMA repaired slope damage on landward shoulder and slope.

Looking east at repaired site on landward shoulder and slope.

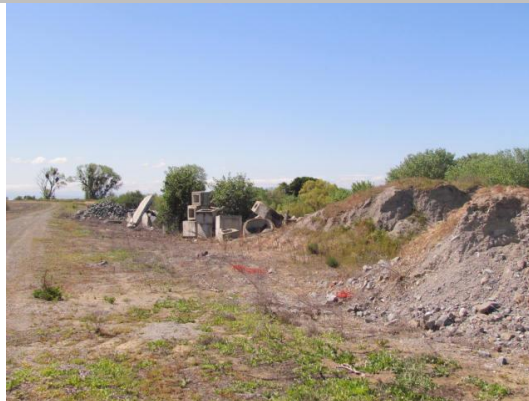
Photo 1 of 1 : SP\_2015\_RD0003\_610\_6\_20150309\_00004.jpg

LM Start	0.25	Rating **	M	Issue No.	6
LM End	0.29	Issue Type +	En	Location *	WS
Category	Earthen Levee			GPS Latitude/Longitude	
				Start	End
Item	Encroachments			38.178635 °	38.178037 °
				-121.653695 °	-121.653715 °
DWR ID	DWR_RD0003_03_s _ 2013_6				
Action/Comments					
Material					
Inspector Comments: Stockpile of rip rap, concrete rubble and sandpile on waterward slope.

Looking east at concrete rubble and other material stored on landward shoulder and slope.
